Manhole Inspection Summary

Manhole # S19U__006MH

Location Address: **GWYNNS FALLS TRAIL**

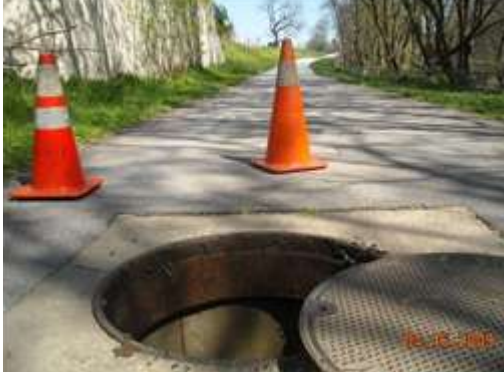
Location View

Comments **LOCATED ON GWYNNS FALLS TRAIL; USED 16LB MAUL TO FORCE OPEN COVER**

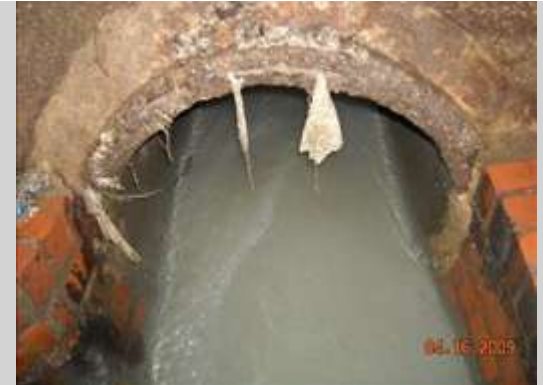
12 O'Clock Outflow

27 in. Circular Gravity Sewer
Pipe Out @ 12 O'Clock

Pipe Height: **26.4** (in.) Rod and Bar (Angled)
Pipe Material: **Clay** ☐ Pipe Lined
Invert Depth: **11.88** (ft.) Flow Characteristics: **Fast**
Deposits: ☒ None ☐ Mud ☐ Sludge ☐ Debris ☐ Grease
Silt Depth: **0** (in.) Deposits Extent:
Infiltration: **None** Pipe Seal Cond: **Sound**

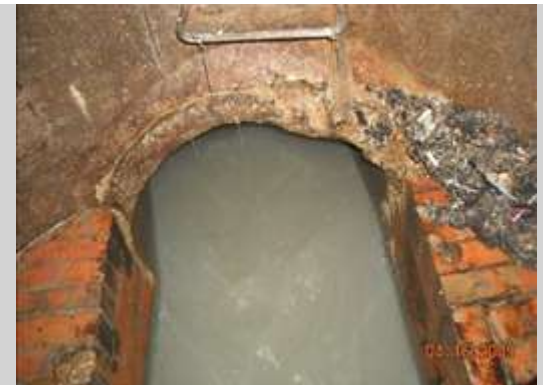
7 O'Clock Inflow

27 in. Circular Gravity Sewer
Pipe In @ 7 O'Clock

Pipe Height: **26.4** (in.) Rod and Bar (Angled)
Pipe Material: **Concrete** ☐ Pipe Lined
Invert Depth: **11.82** (ft.) Flow Characteristics: **Fast**
Deposits: ☒ None ☐ Mud ☐ Sludge ☐ Debris ☐ Grease
Silt Depth: **0** (in.) Deposits Extent:
Infiltration: **None** Pipe Seal Cond: **Sound**
